KEMRON Project: SE 4352-013

September 21, 2007

**Re: Public Supply Well Abandonment
Providence Park Remediation Project - Phase I
13440 Providence Park Road
Alpharetta, Fulton County, Georgia**

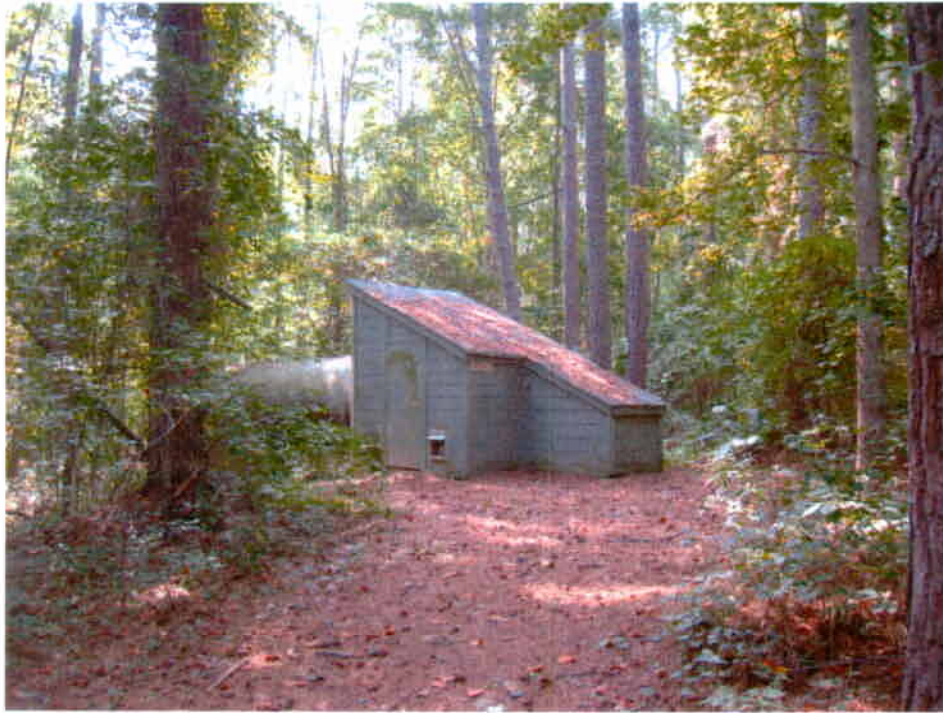
Photograph 1: View of Supply Well House and AST.

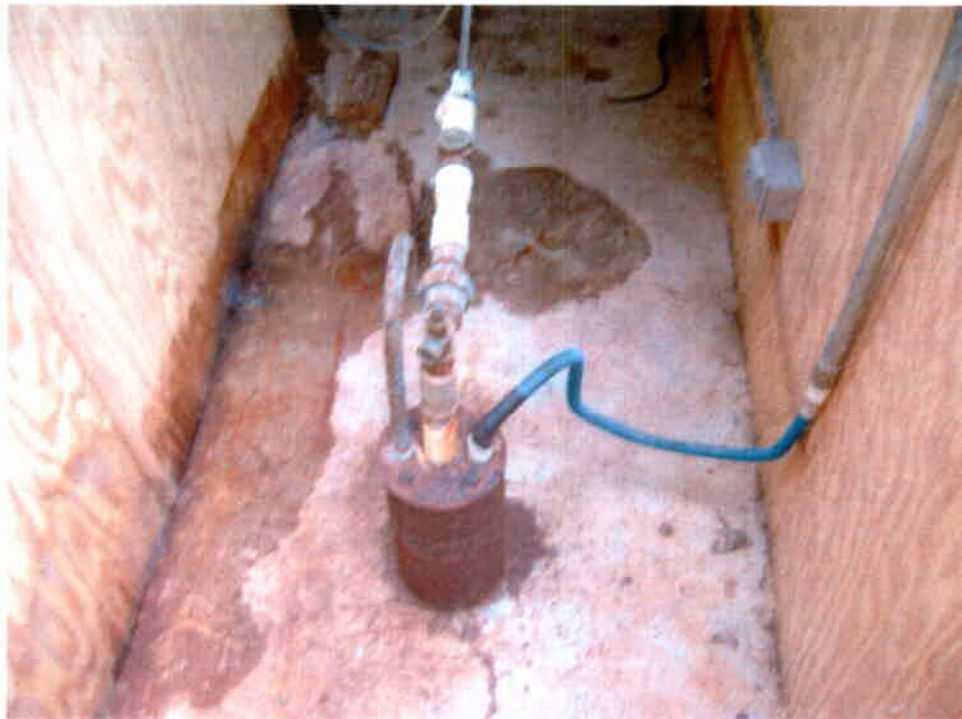
The concrete foundation for the well house was built around the 6" steel casing of the public supply well. The 6" steel casing was estimated to extend approximately 25 feet below ground surface (bgs.), based on torque rests found on piping and condition of the casing. At the surface of the well was a rubber seal in which a 1-inch Schedule 80 PVC piping was fed through and advanced inside the well to a depth of 300 feet bgs, where the well pump was located. The approximate depth to water was 55 feet bgs. Based on gauging and material volume used, the total depth of the public supply well is estimated to be 600 feet bgs.

Photograph 2: View of the steel casing of the well.

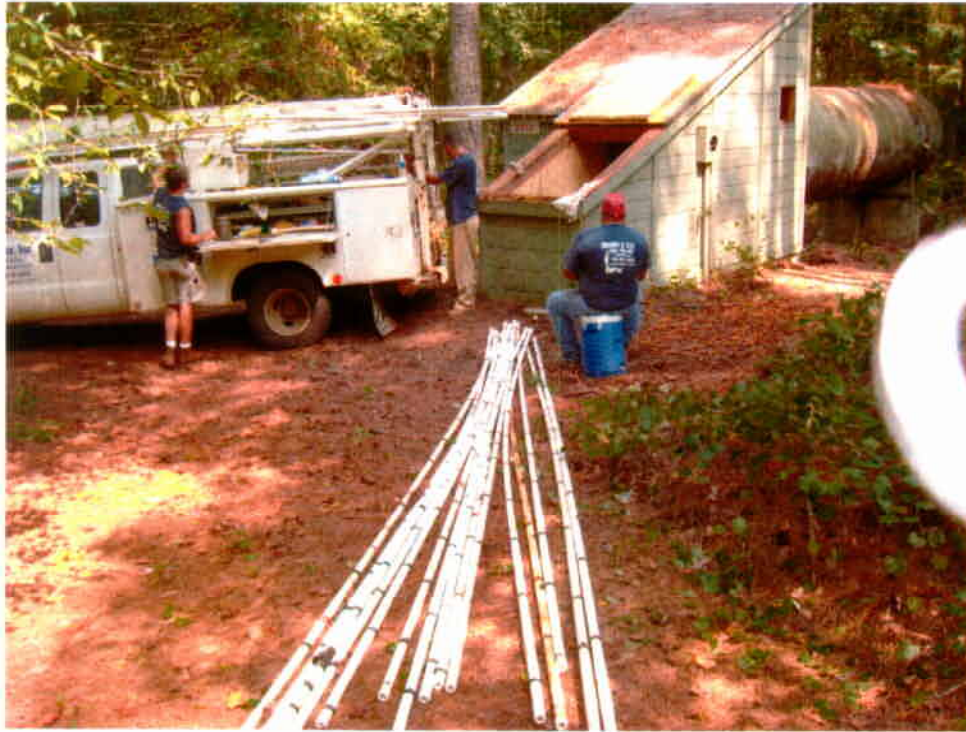
Photograph 3: Removal of 1- inch piping in the well

After removing the piping and well pump, the boring was filled with a gravel pack, consisting of #57-stone, to a depth of 60 feet bgs. At 60 feet bgs a concrete seal of approximately 5 feet was placed in the boring. Next, another gravel pack of #57 stone

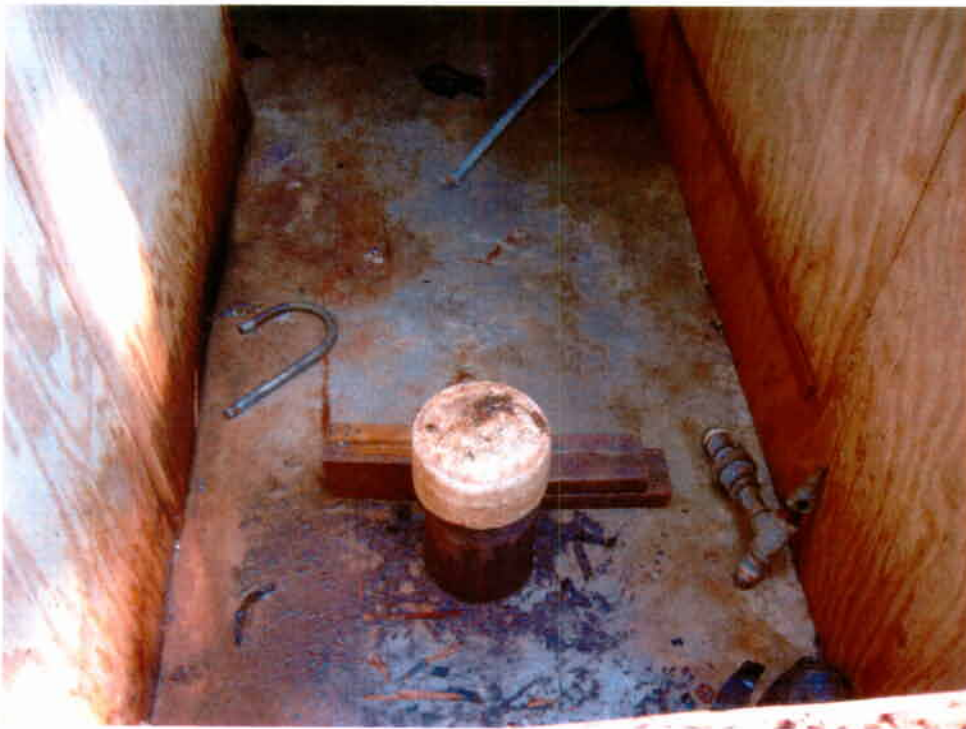
Photograph 4: View of the well sealed prior to demolition.

was placed in the well to a depth of 30 feet bgs. At 30 feet bgs, a second 5-foot concrete seal was placed. A final gravel pack of #57 stone was then brought up to 4 feet bgs, and a final concrete cap was placed to 2 feet bgs. The top 5-feet of steel casing was removed from the bored hole and excavated soil was backfilled to the existing surface. Selected photographs of the abandonment activities are attached.

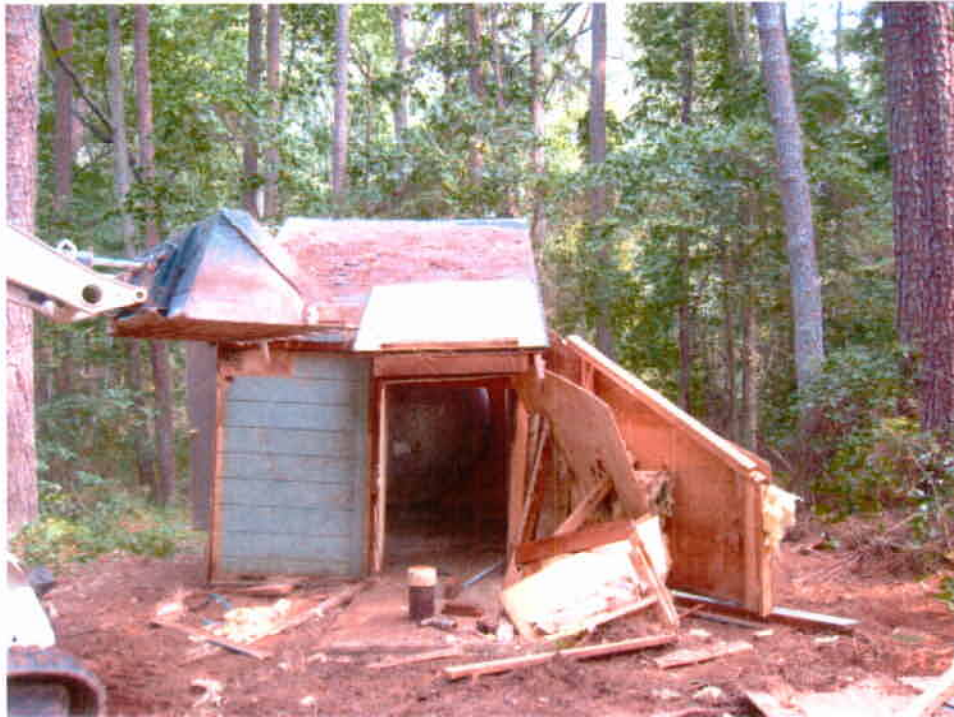
Photograph 5: Removal of the Well House

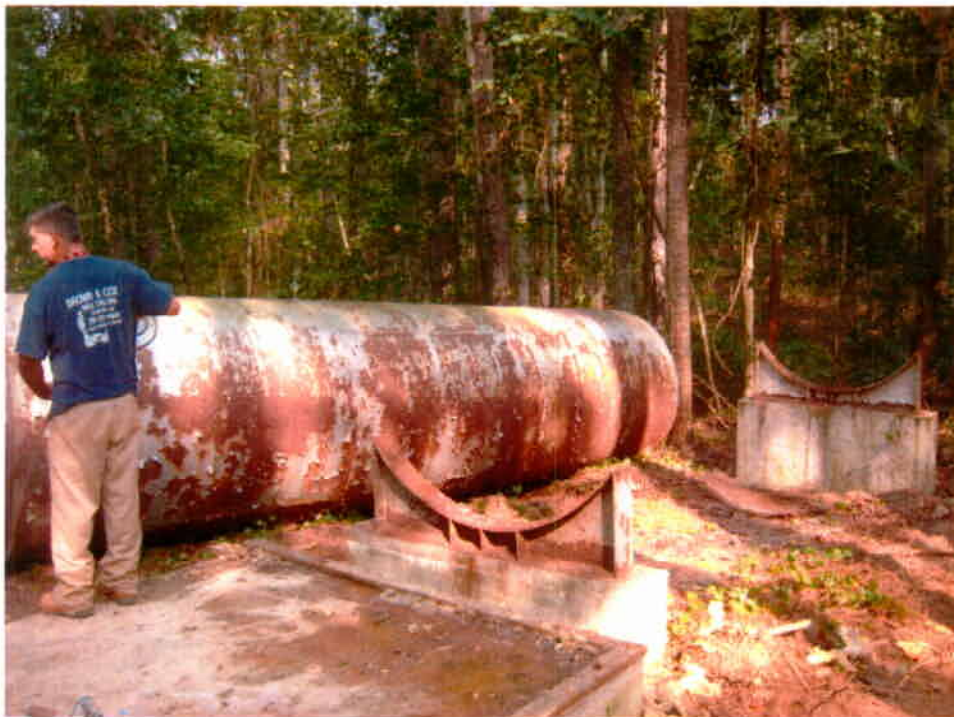
Photograph 6: Removal of the AST

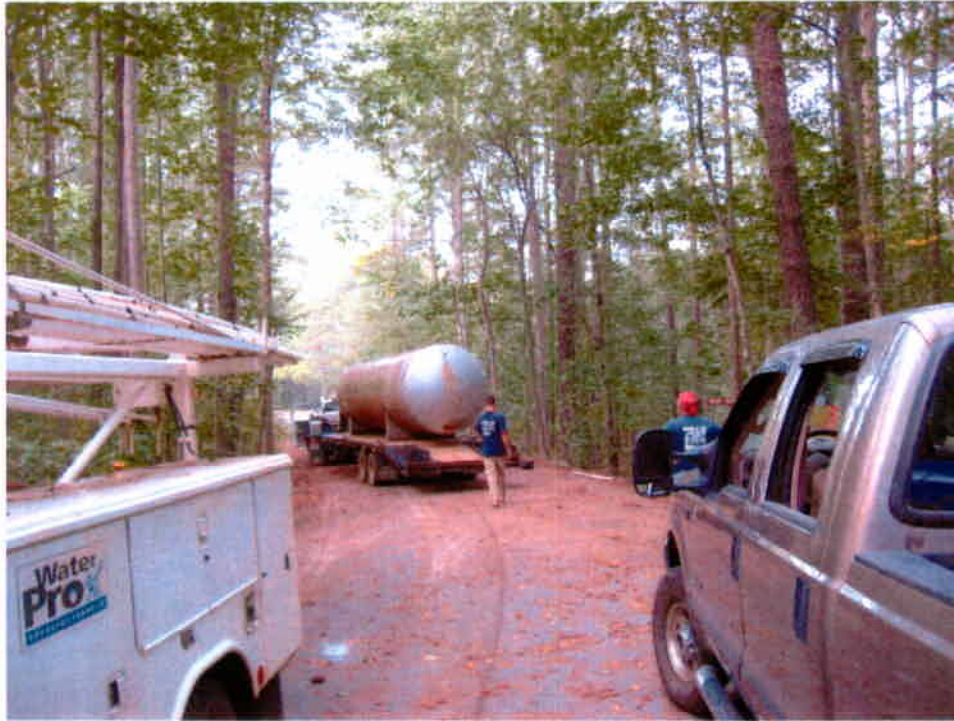
Photograph 7: Transportation of the AST

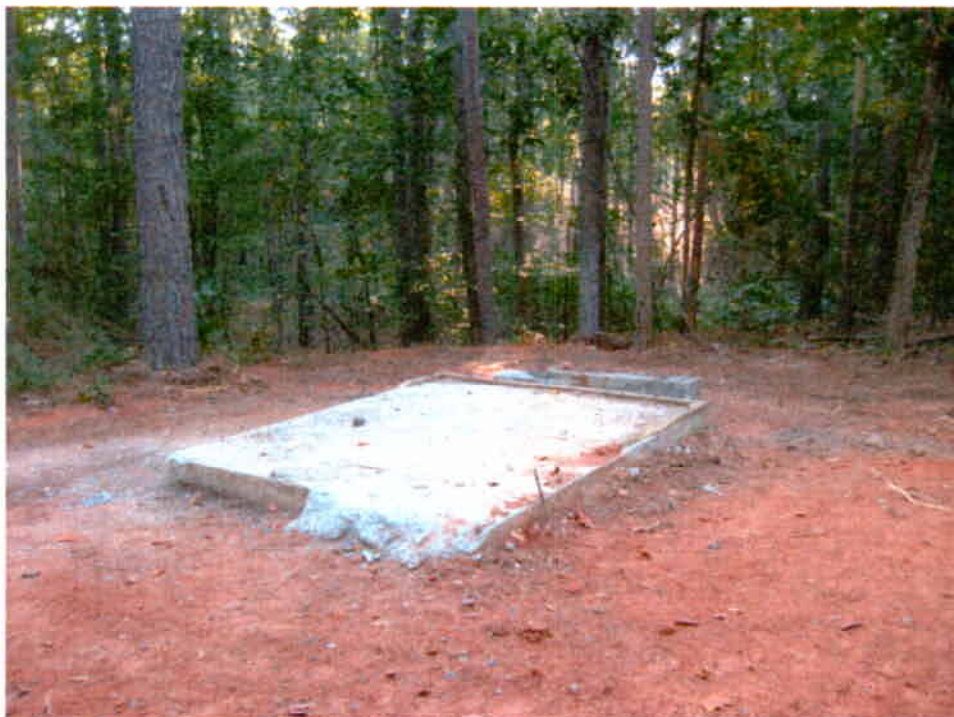
Photograph 8: View of the area after abandonment activities completed
